RISK ANALYSIS AND TREATMENT FOR CUTTING PLASMA PROCESS AT PT.TOYOTA MOTOR MANUFACTURING INDONESIA USED FAILURE MODE AND EFFECT ANALYSIS (FMEA)

Syahrullah [1], Heriyono Lalu [2], Yunita Nugrahaini[3]

[1,2,3] Universitas Telkom, Bandung
**syahru1lah@student.telkomuniversity.ac.id[1], heriyonolalu@telkomuniversity.ac.id[2],
yunitanugrahaini@telkomuniversity.ac.id[3]**

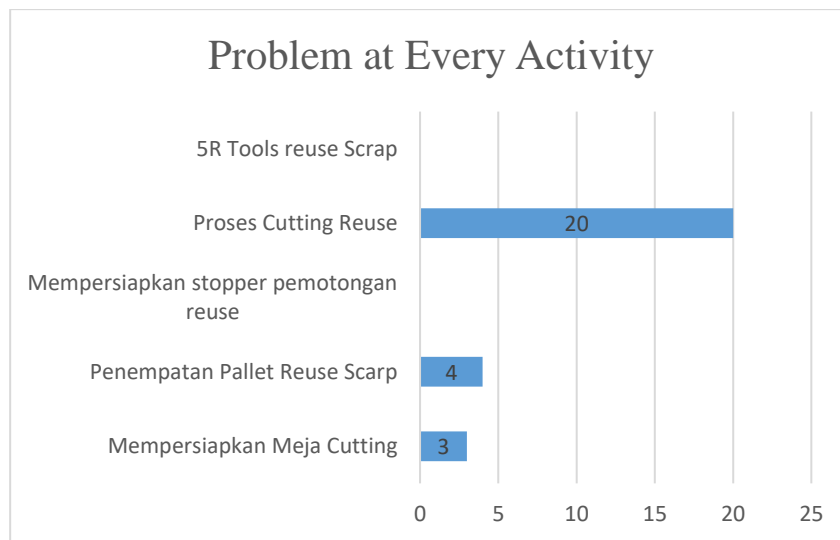
Figure 4. 1 Chart of problem at every activity

Based on Figure 4.2 which explains the problems that exist in each activity in January, February, March, in 2020. The problems listed in table data finding problems in the *Plasma Cutting* work process, then adjusted to each activity. It is known that in the activity of preparing the cutting table there were 3 problem occurrences, in the activity of palletizing reuse scrap there were 4 problems, in the activity of preparing the reuse cutting stopper there were no problems, in the activity of the *Plasma Cutting* process there were 20 occurrences of problems, in the activity of R tools reuse scrap there were no problems. there is a problem. It can be concluded that from every activity in thework process *Plasma Cutting* at PT. Toyota Motor Manufacturing Indonesia, the activity that has the highest average occurrence of problems is activity during the process *Cutting Reuse* with 20 events in 3 months, where the problem is caused by The plasma TIP is damaged and the plasma torch cable is broken.

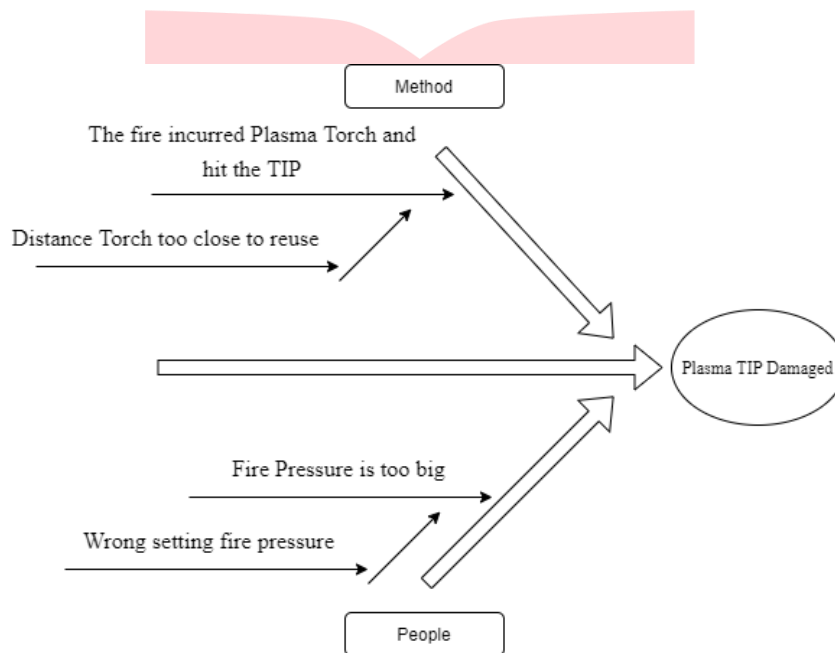
Figure 4.2 Causes Analysis of Plasma TIP damaged

Based on Figure 4.10, it is known that the results of the analysis using fishbone caused the problem in the TIP plasma was damaged. The TIP plasma was damaged due to the method aspect, which is the flame released by the torch hit the Plasma TIP, because the distance of the torch was too close to reuse.

No	Failure Mode	Cause Failure Mode	Risk Treatmen
1	Plasma TIP damaged	The fire pressure is too high	Make work instructions as reminders and will visualized with posters
		Torch distance is too close to reuse	Make work instructions as reminders and will visualized with posters
No	Failure Mode	Cause Failure Mode	Risk Treatmen

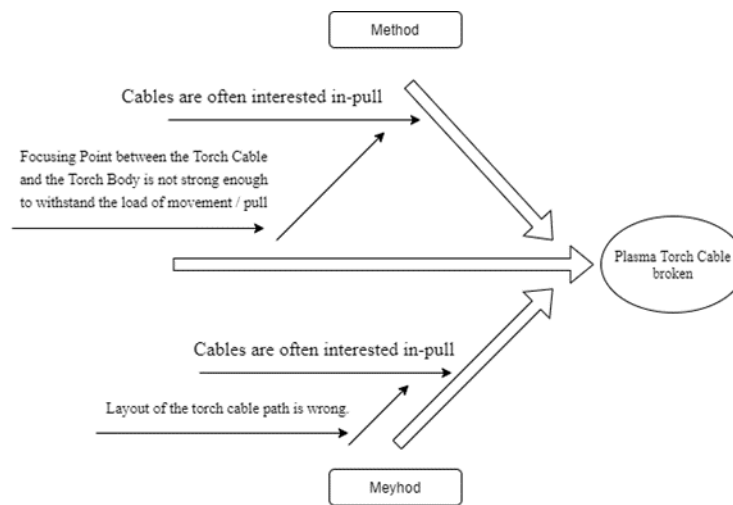
Figure 4.1 Causes Analysis of Torch Plasma Cable broken

Based on Figure 4.13, it is known that the results of the analysis using fishbone caused the problem with the broken torch cable. The torch cable is caused by the method aspect, namely because the cable is often pulled, the torch gun cable which makes the work process less comfortable, is caused by the wrong layout of the torch gun path placement.

2	Plasma Torch Cable broken	The Focusing Point between the Torch Cable and the Torch Body is not strong enough to withstand the load of movement / pull	Make an additional part, namely the Clamp part to streng then the bond between the Torch Cable and the Torch Body
		Layout of the torch cable path is wrong.	Re-layout Cable path

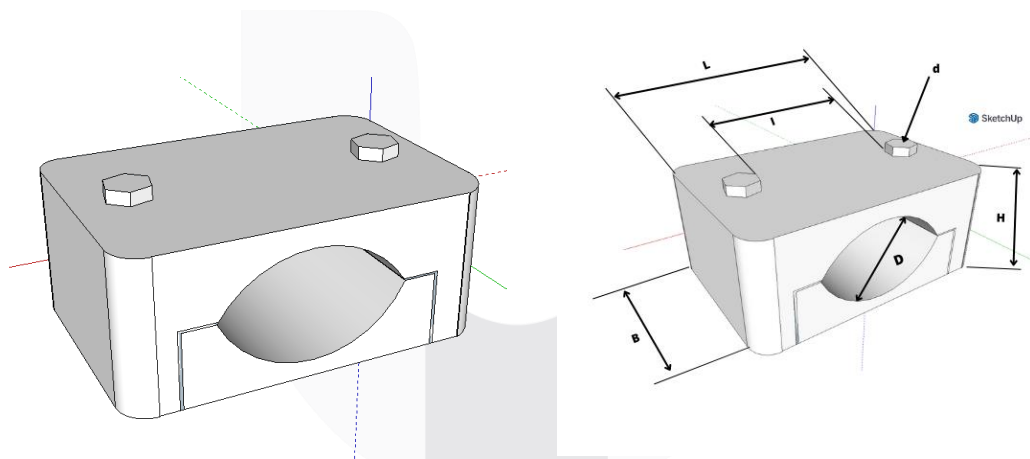
Figure 4. 6 Proposed Design

Based on Figure 4.6 above that is the design of the Clamp part that recommended to strengthen the fulcrum on the Torch Cable with the Torch Body. The figure describes the specifications for the dimensions of the units in the part. for the material used in the clamp part is Black polyamide (PA66). fiberglass-reinforced, based on the Material data sheet from the Journal (PA66), (Wilhelm Herm. Muller GmbH & Co. Kg, 2018) material Black polyamide (PA66) has the following advantages :

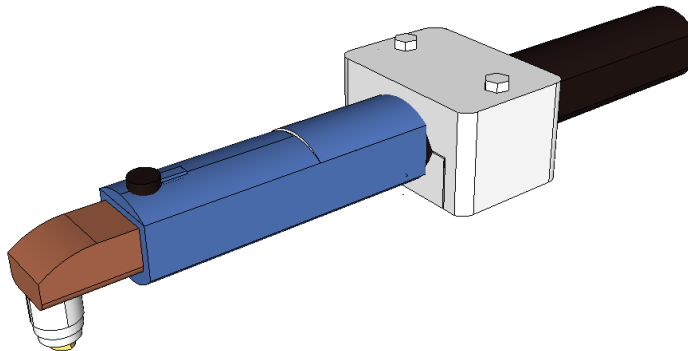
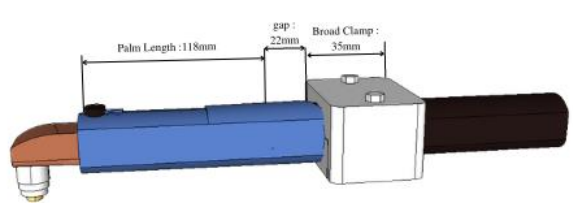
Figure 4.7 Torch Cable that already compare with Clamp

Based on Figure 4.7 above is the result of the proposed design that has been installed on the Torch, the proposed design with *Fail mode* Plasma Torch Cable broken, aims to strengthen the Torch Cable bond with the Torch. In the clamping section there are bolts that function to strengthen or weaken the bond according to conditions, this is The aim is that the clamps can be used repeatedly.
